PNW-71

December 1967

GRASS-LEGUME MIXTURES FOR ROADSIDE SOIL STABILIZATION

C. T. Dyrness, *Principal Soil Scientist*

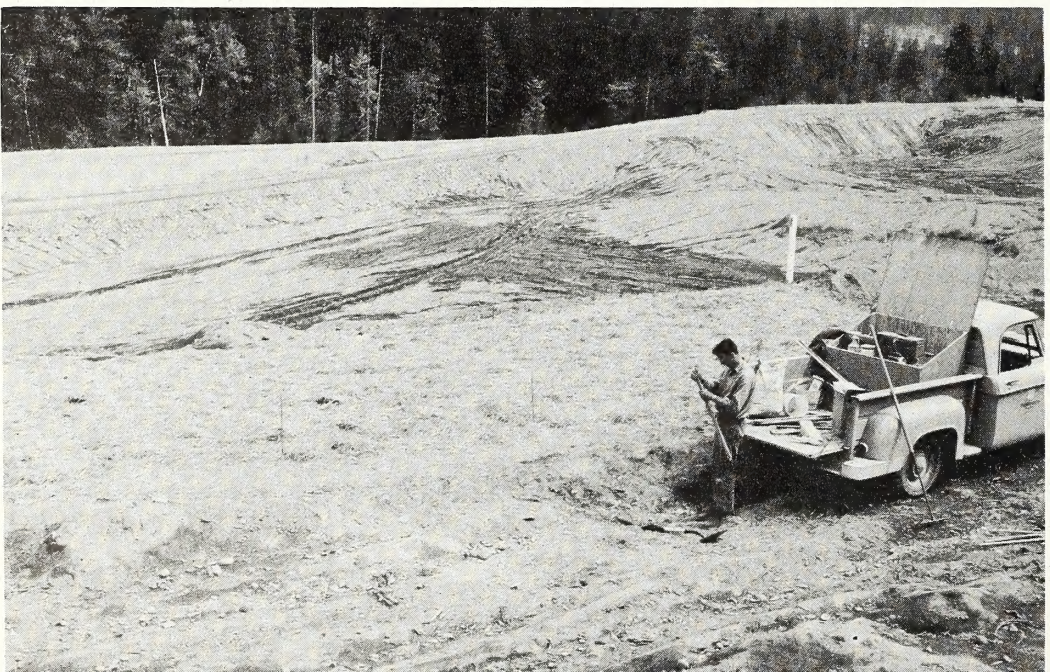
Figure 2.--Spring legume plot immediately after seeding, near Cougar Dam, Blue River District, Willamette National Forest. Note the grass straw mulch.

Legume planting plots are located near Divide Lookout in the Alsea District, Siuslaw National Forest (Coast Ranges), and at the edge of a borrow pit near Cougar Dam in the Blue River District, Willamette National Forest (western Cascades). Elevations are 1,700 feet and 1,200 feet, respectively. Both plot sites are essentially level and comprised solely of subsoil material (figs. 1 and 2). The Alsea plots

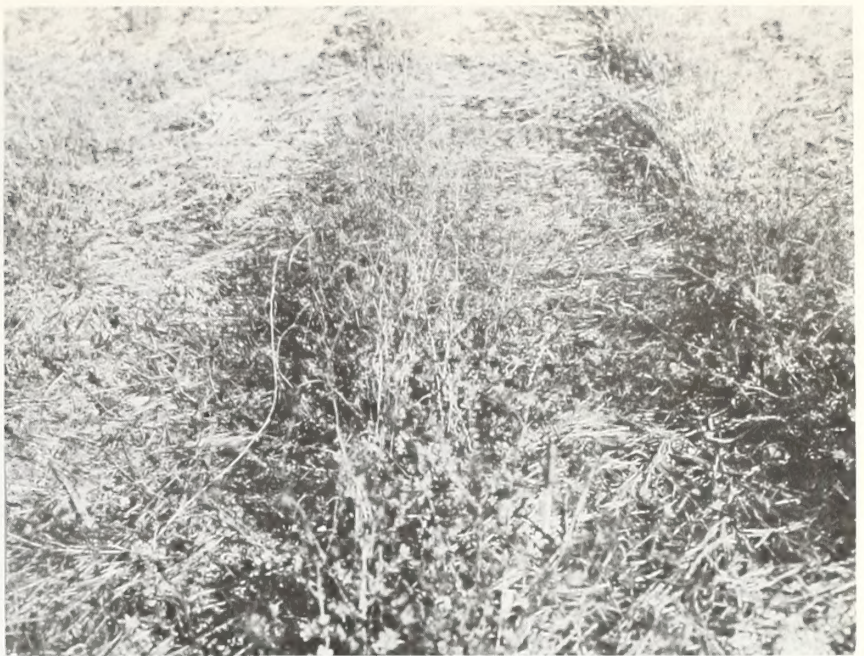
Figure 3.--Fall-seeded big
trefoil plants 2 years
after seeding
(Alsea plot).

1. *Big trefoil* (fig. 3). In all cases, this species germinated very well, and for the first 2 months, rows were extremely dense.

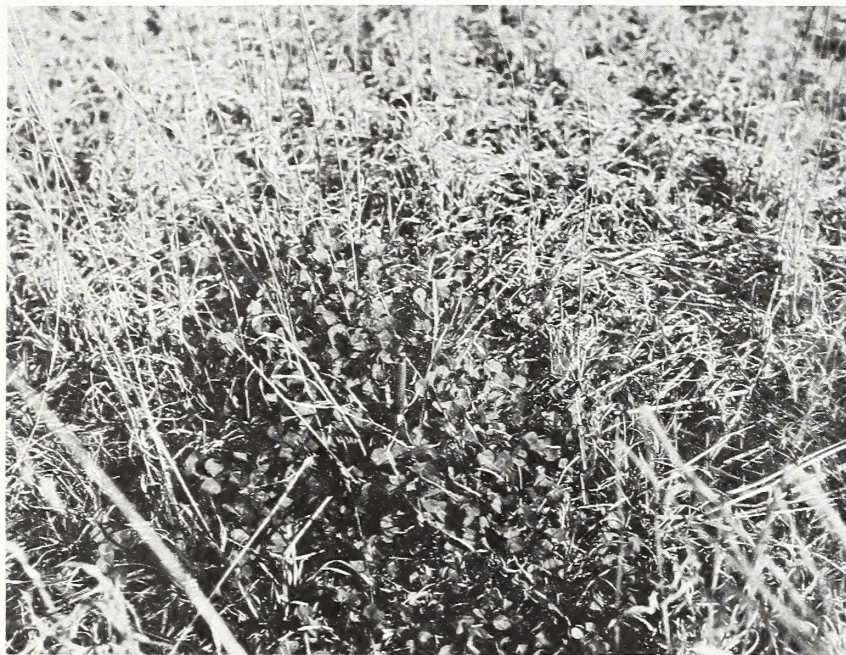
Figure 4.--Spring-seeded New Zealand white clover plants 1-1/2 years after seeding (Alsea plot).

3. *New Zealand white clover* (fig. 4). This variety performed in a manner almost identical to white Dutch clover in the Alsea plots. In the Blue River plots, it showed slightly better growth than white Dutch clover. Therefore, New Zealand white clover may prove to be better adapted than white Dutch clover to conditions in the western Cascades.

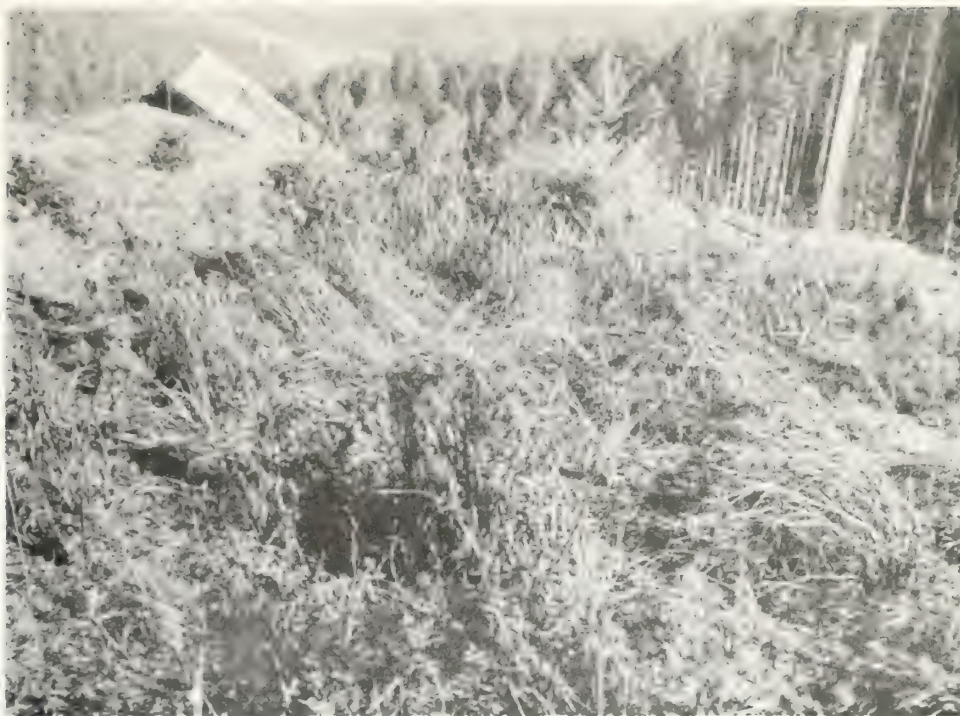
Figure 5.--Transplant area in the Alsea plot 2 years after planting. Note luxuriant growth. Rows, difficult to distinguish because of lateral spread, are from left to right: cicer milkvetch, perennial vetch, big trefoil, and flat pea.

8. *Perennial vetch*. This species was seeded only in the spring. Its performance at Blue River was poor. However, it grew fairly well on the Alsea plot and showed good vigor even though the plants tended to be small. Perennial vetch transplants also grew poorly at Blue River despite fairly good survival. Transplants on the Alsea plot generally grew very well to a maximum spread of about 2-1/2 feet (fig. 5).

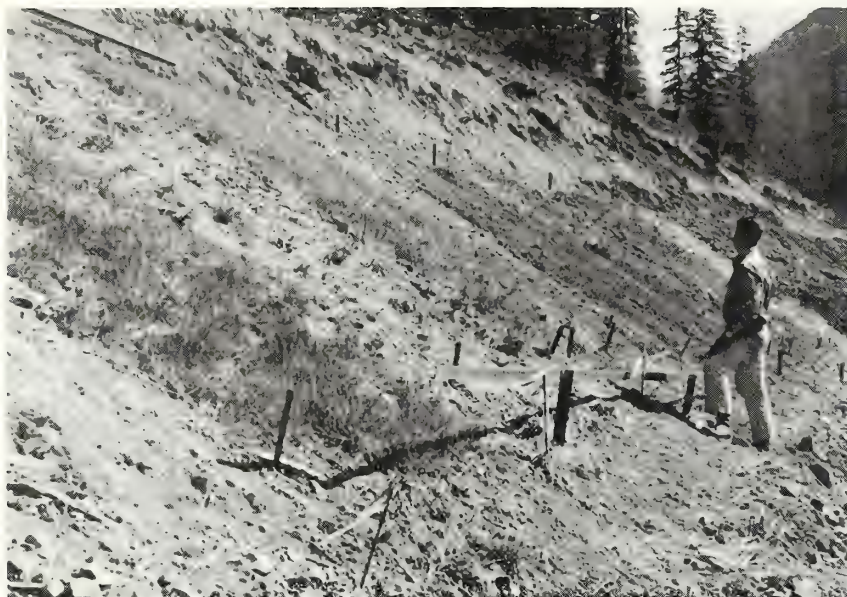
Figure 7.--Side-cast plots 7 months after seeding. The cable for measuring the slope profile is stretched between the channel irons.

Soil movement on the plots was monitored by periodic measurements of the distance between points on a stretched wire cable and the mineral soil surface directly beneath. The measurement was accomplished with a steel tape and attached plumb bob held next to the profile cable at the appropriate point. Three transects, 1 foot apart and extending up and down slope in the central 2-foot strip, were measured in each plot. Fifteen measurements were made along each transect at 1-foot intervals. The first measurement was made 1 foot below the upper boundary of the plot. Therefore, the elevation of the upper 15 feet of slope was measured.

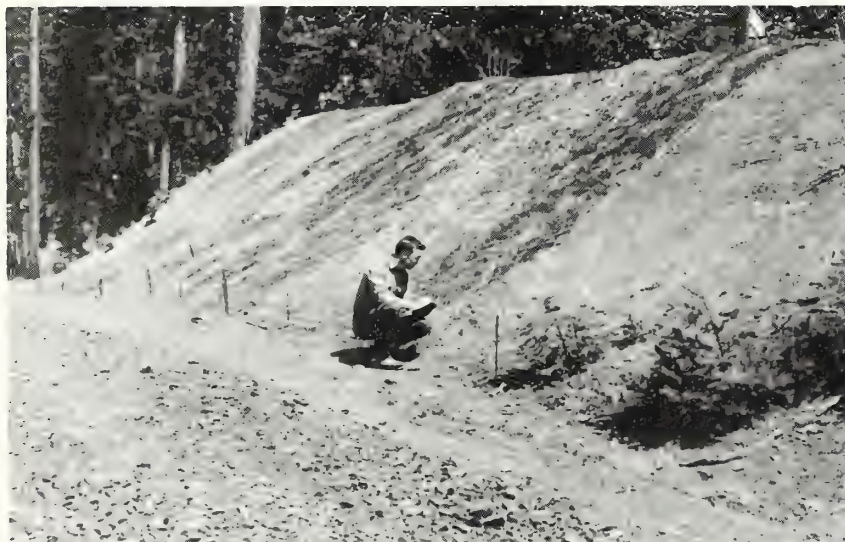
Figure 8.--Backslope plots 7 months after seeding.

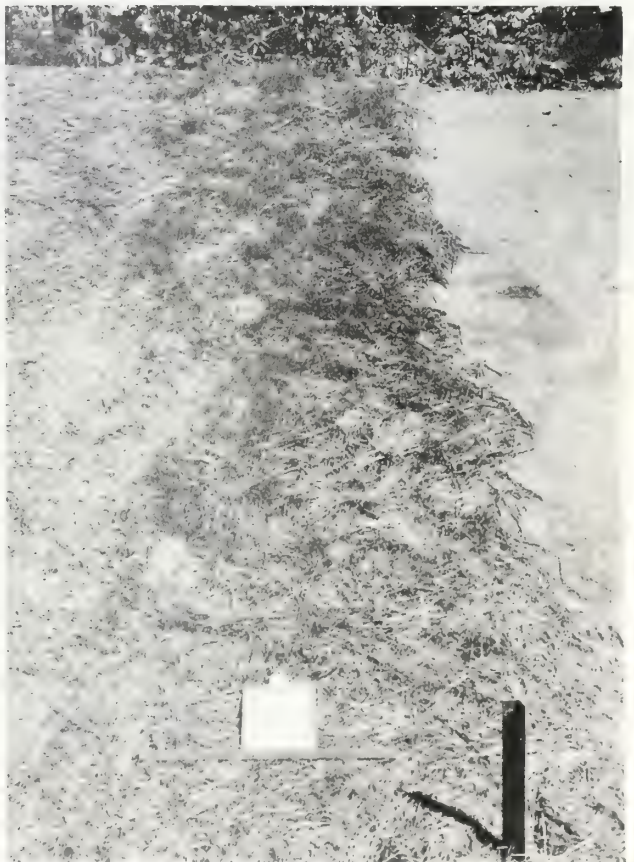
**Figure 10.--Experimental mixture No. 2
on backslope 7 months after seeding.**
